STRUCTURAL ANALYSIS
OF THE
SOUTH MOORING DOLPHIN
U. S. NAVCOMSTA
H. E. HOLT
EXMOUTH AUSTRALIA

FPO-1-85 (5)
MAY 1985

OCEAN ENGINEERING
AND CONSTRUCTION PROJECT OFFICE
CHESAPEAKE DIVISION
NAVAL FACILITIES ENGINEERING COMMAND
WASHINGTON, D.C. 20374

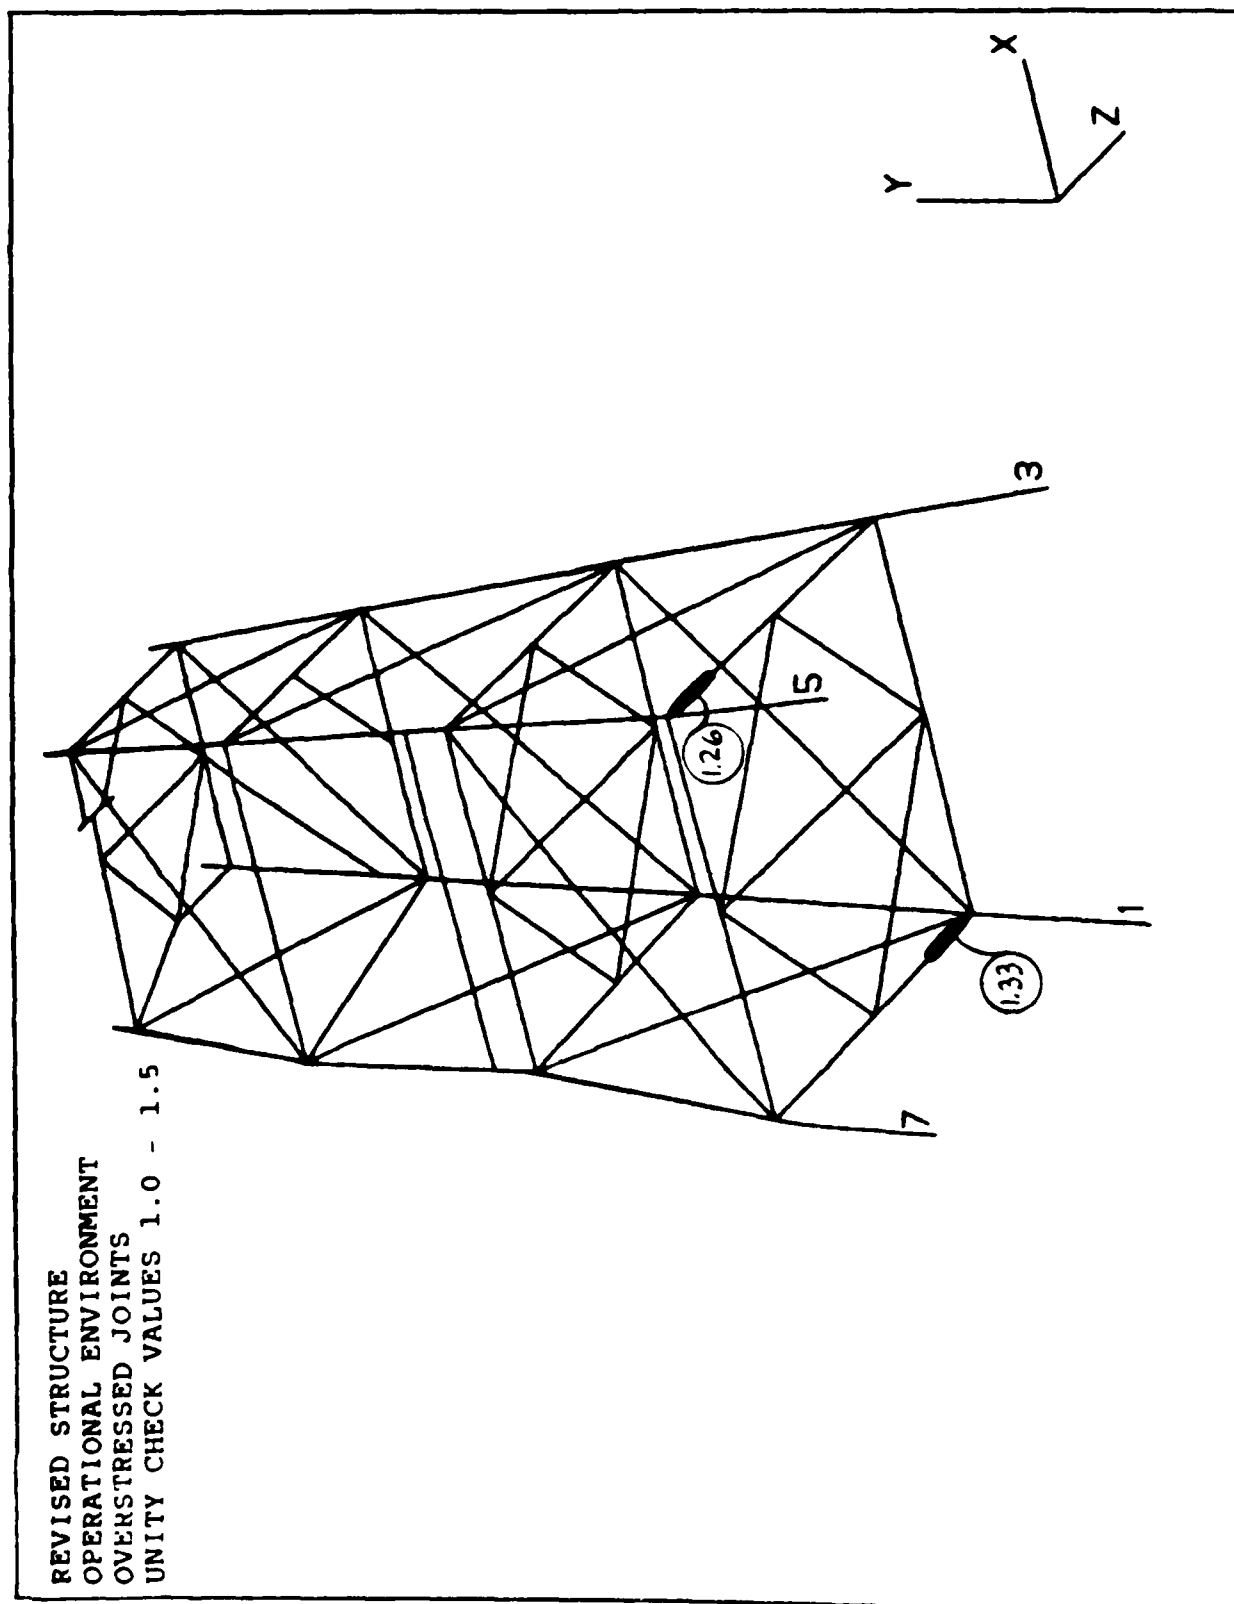
FIGURE 5-2

The revised structure also endures the operational environment without any overstressed members. The JOINTCAN routine found just two joints we can consider overstressed. Their location and degree of stress is shown in figure 5-2.

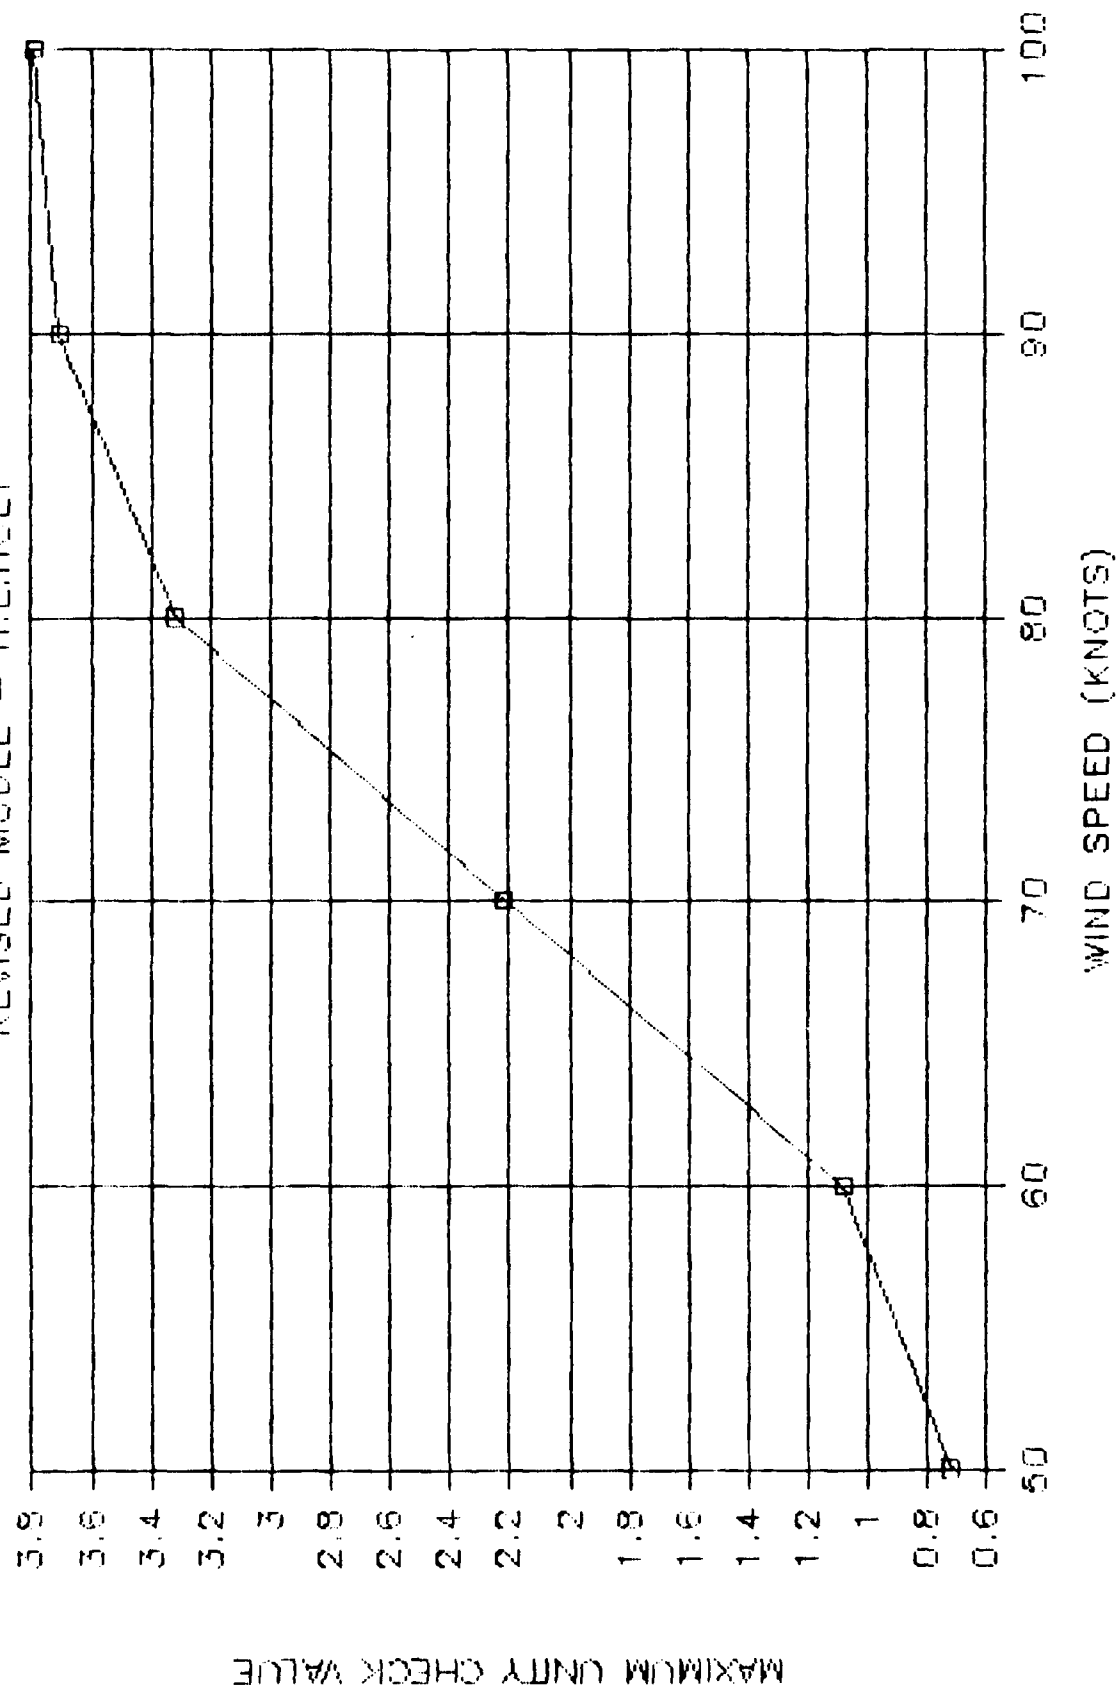
FIGURE 5-6

After determining that the dolphin would be overstressed in a hurricane environment, we sought to estimate the magnitude of a storm which would just start to overstress the structure's joints. We examined the structure's response to winds of 50, 60, 70, 80, 90 and 100 knots. Table 5-1 shows wind speed vs maximum unity check values for all of the structure joints. We observed from figure 5-6 that a storm with sustained 64 knot winds would stress at least one joint to a unity check value of 1.5 (indicating a failure).
